**APPENDIX C**

**PHOTOGRAPHS FROM SEPTEMBER 2006 SITE INSPECTION**

Site Investigation Plan  
Florence Copper In-Situ Mine Project  
Florence, Arizona

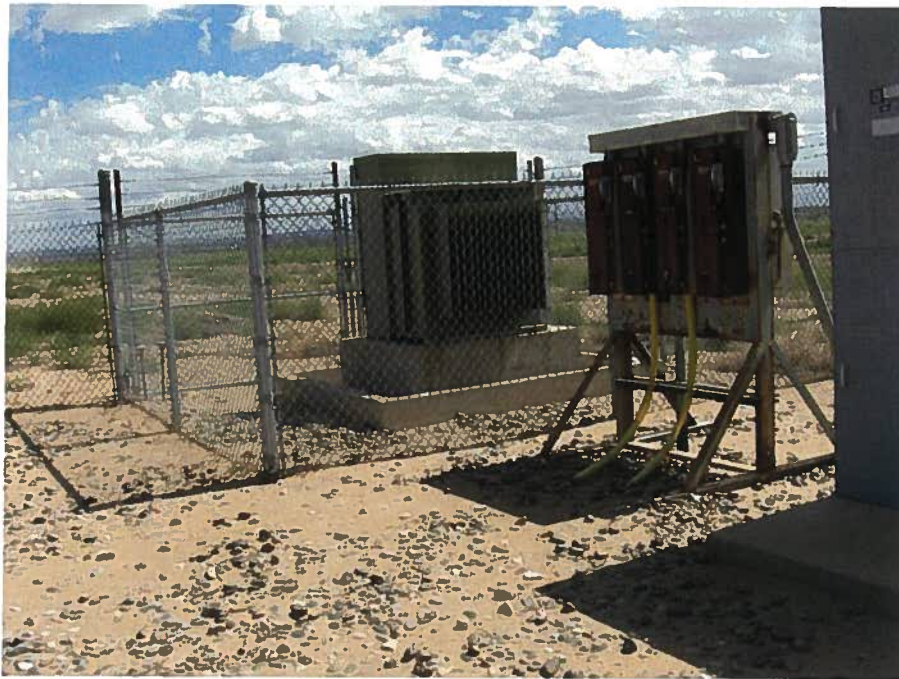
Photograph 1  
Transformer and electrical panels adjoining the south side of evaporation pond.

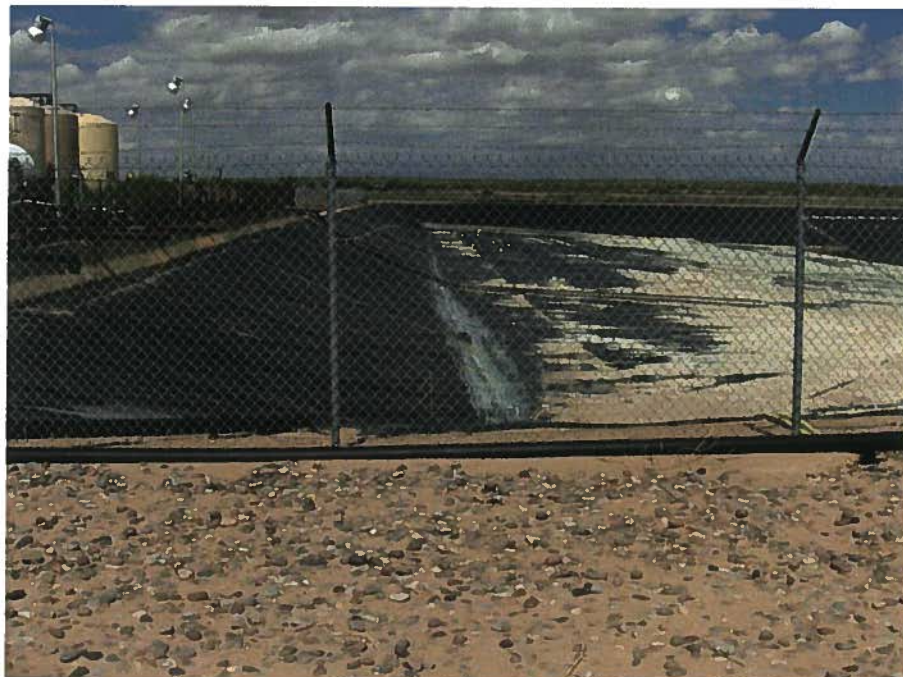
Photograph 2  
West side of the evaporation pond.

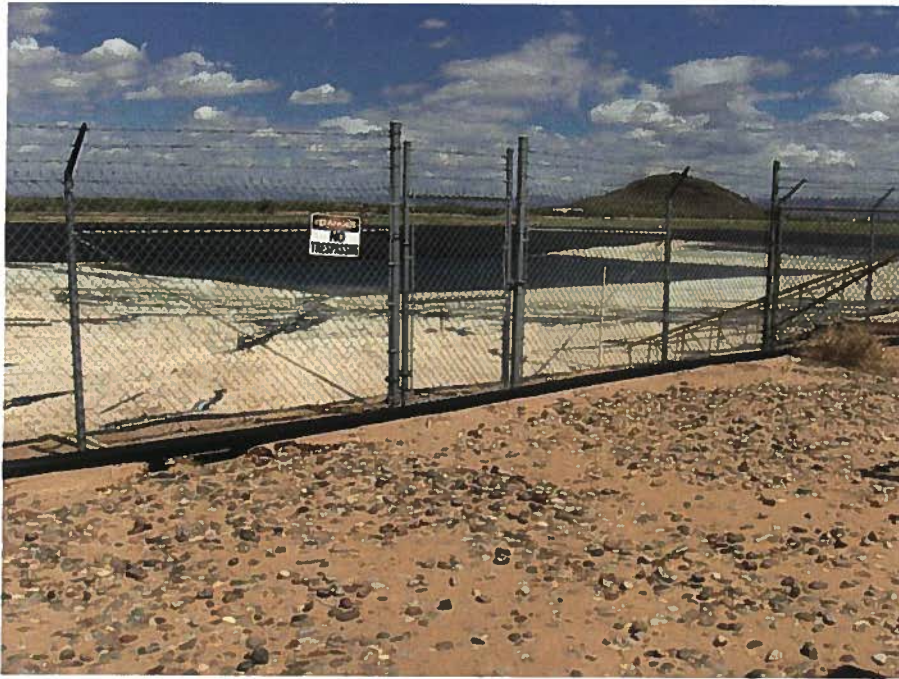
Photograph 3  
View showing the fence around the pond and remaining storm water accumulation within the pond.

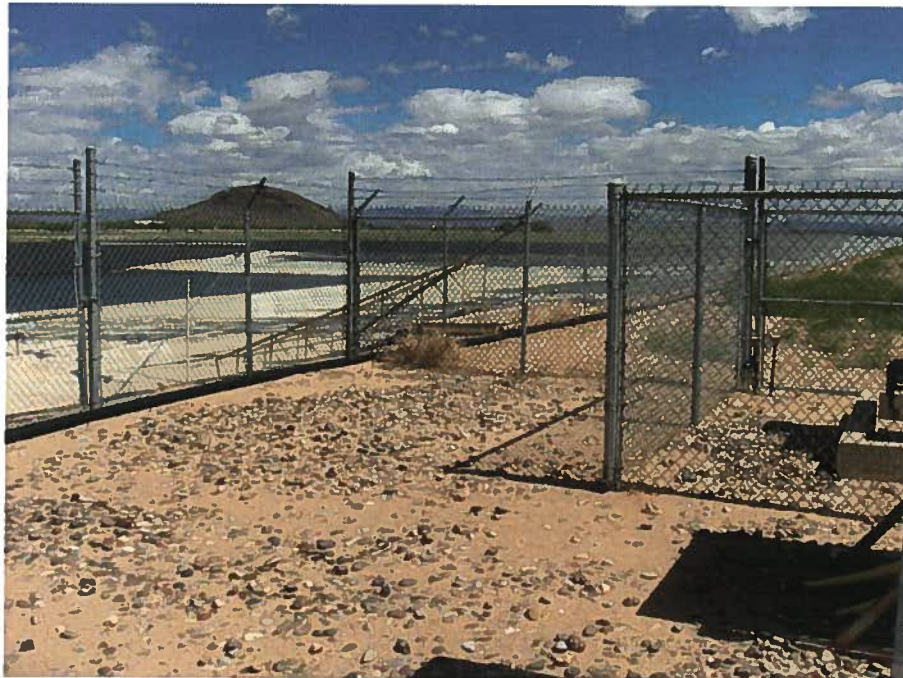
Photograph 4  
East end of the evaporation pond.

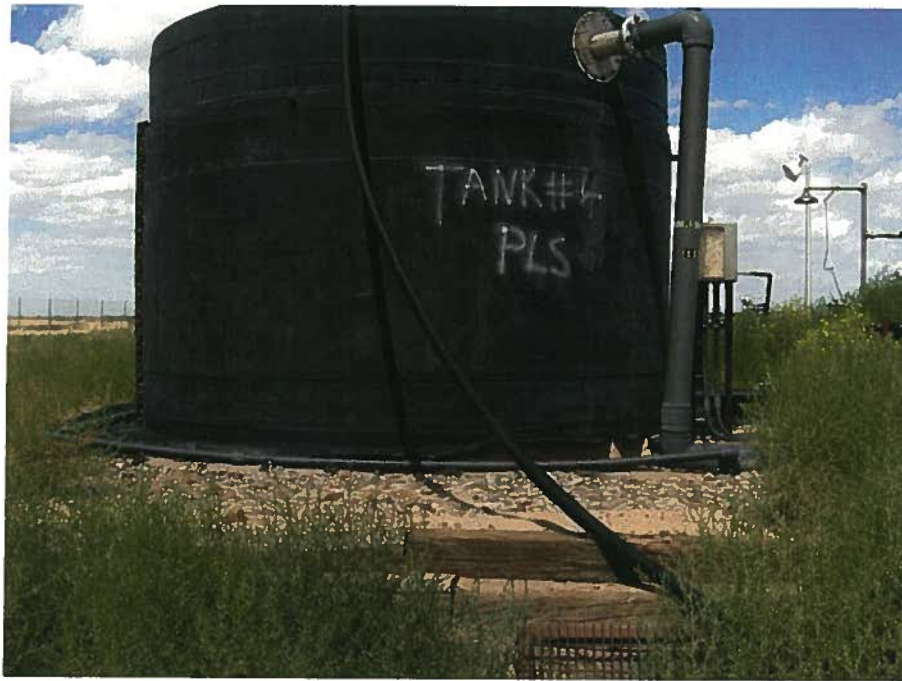
Photograph 5  
PLS aboveground tank located in the tank farm adjoining the evaporation pond to the west.

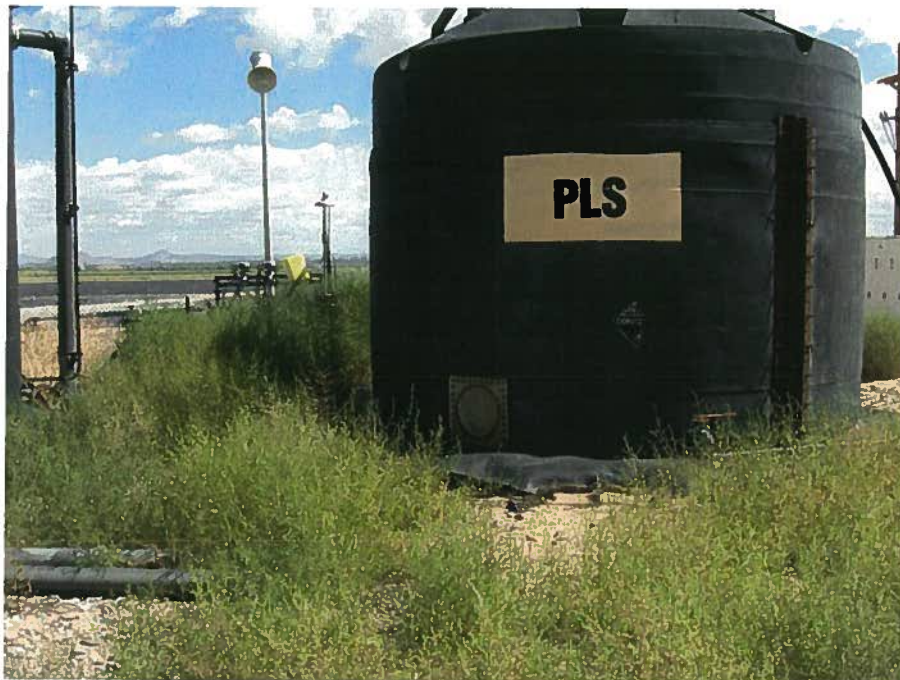
Photograph 6  
Another view of the PLS tank showing the north side of the tank.

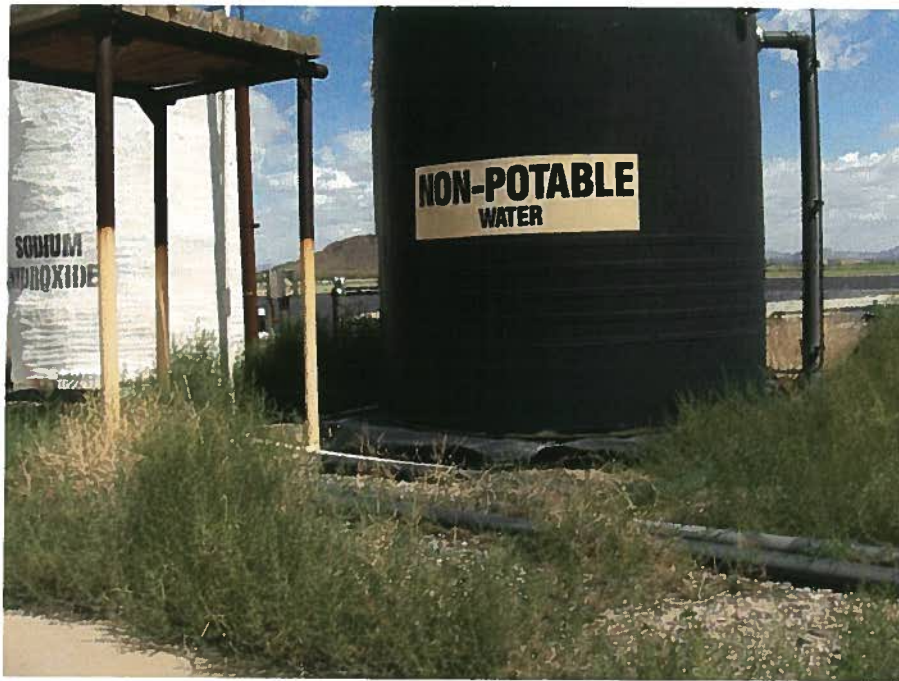
Photograph 7  
Non-potable water tank in center view, sodium hydroxide tank to the left. Tanks were reportedly empty and not in use.

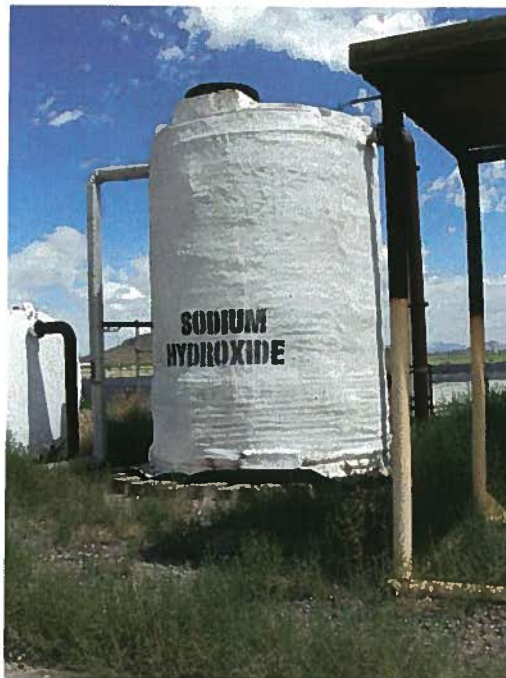
Photograph 8  
Sodium hydroxide tank in the tank farm area.

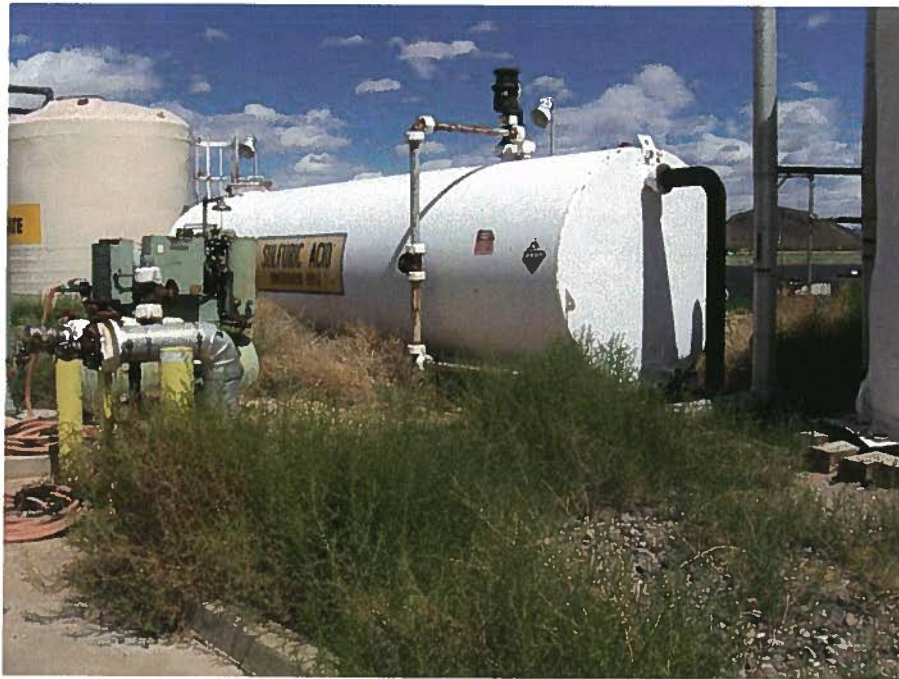
Photograph 9  
View of the piping in the tank farm and sulfuric acid storage tank.

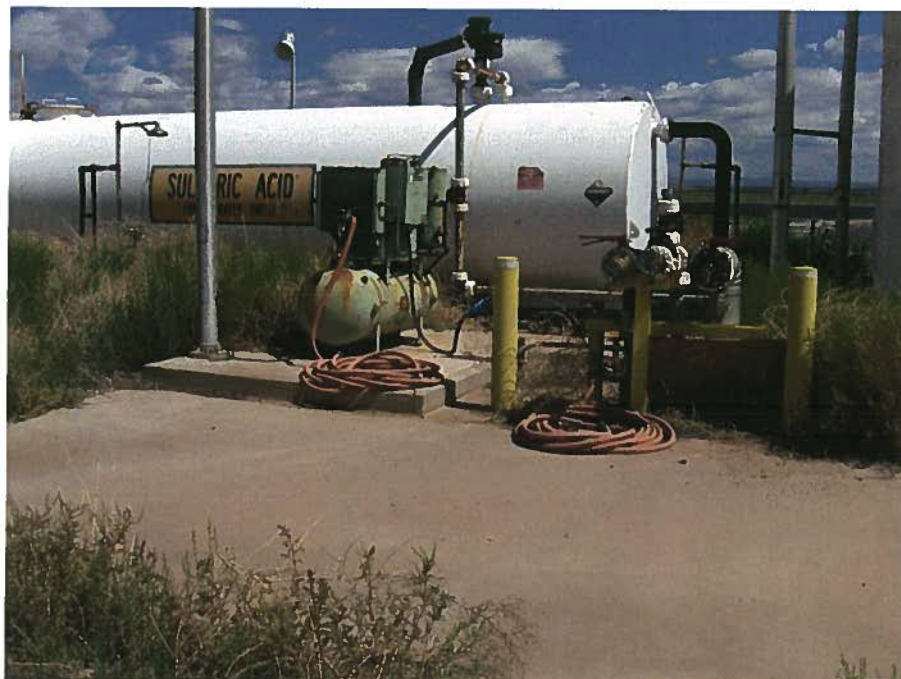
Photograph 10  
View showing the sulfuric acid tank and small air compressor in the tank farm.

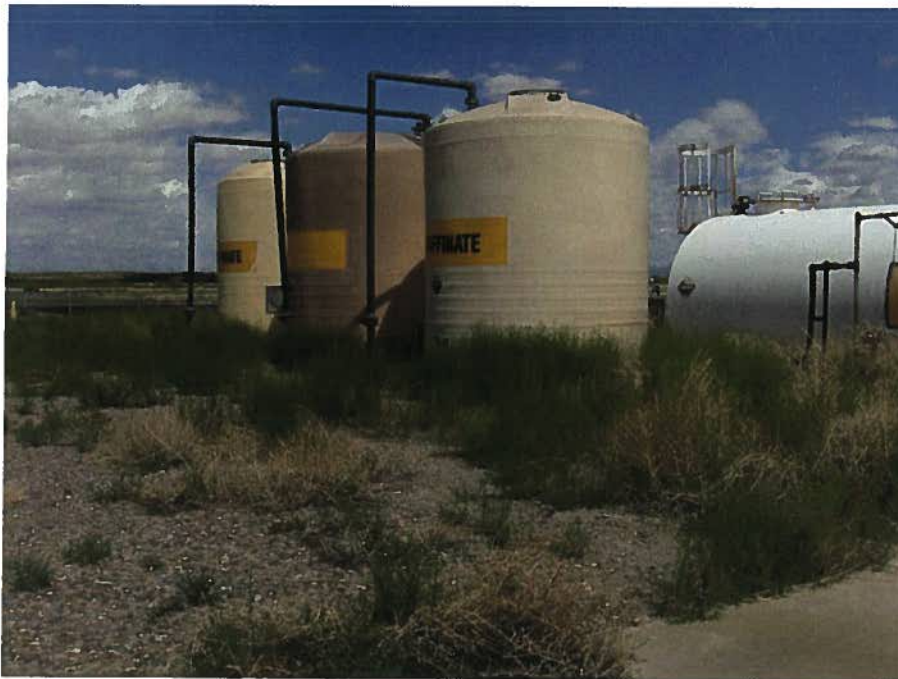
Photograph 11  
View showing the raffinate tanks.

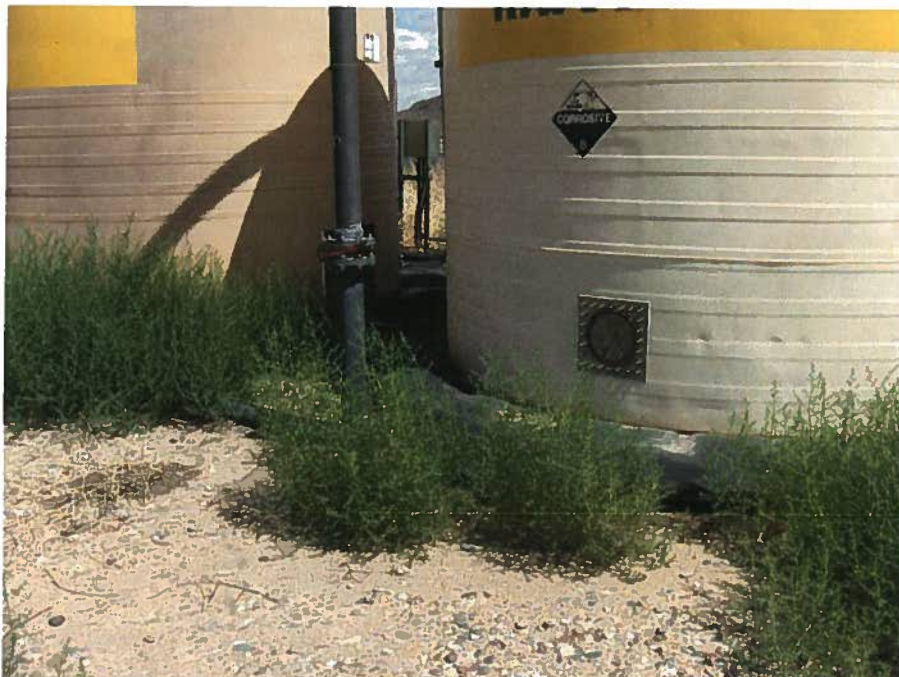
Photograph 12  
View of the ground around the raffinate tanks.

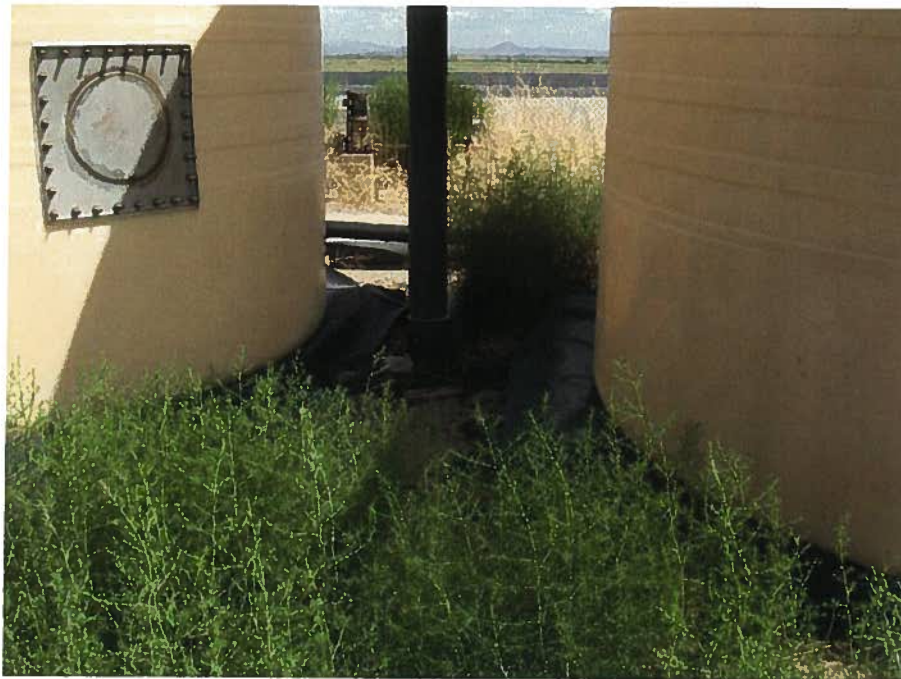
Photograph 13  
View of the piping around the raffinate tanks.

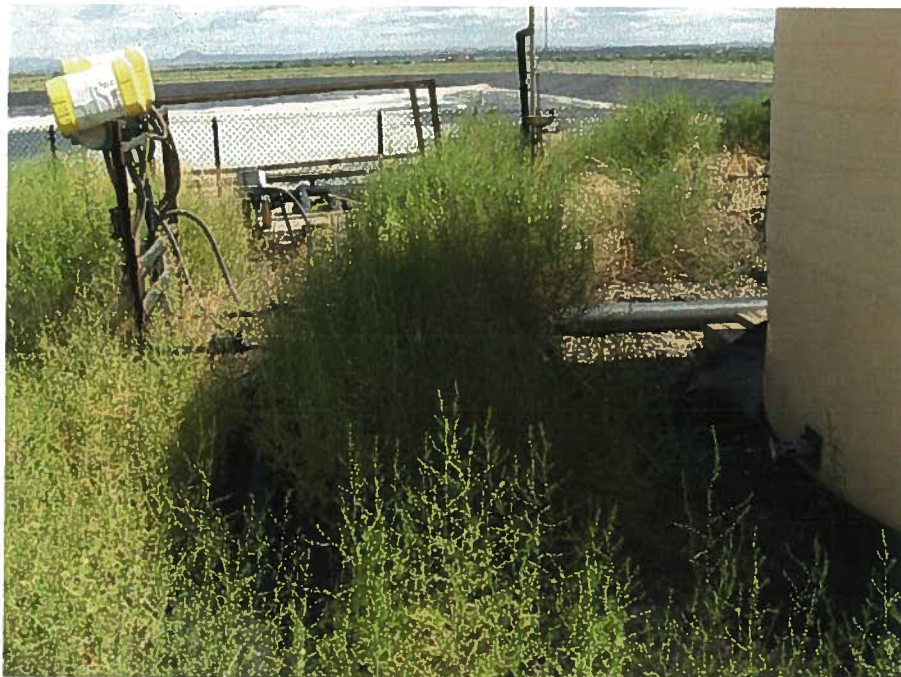
Photograph 14  
View showing the piping and other equipment in the tank farm area with the evaporation pond in the background.

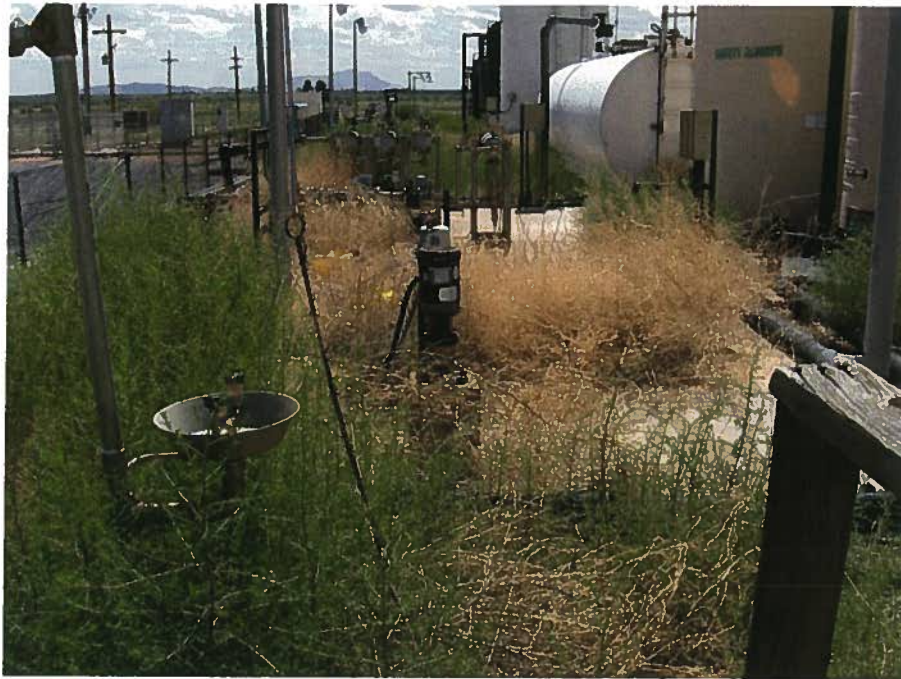
Photograph 15  
View along the east side of the tank farm. The evaporation pond is to the left in the photograph.

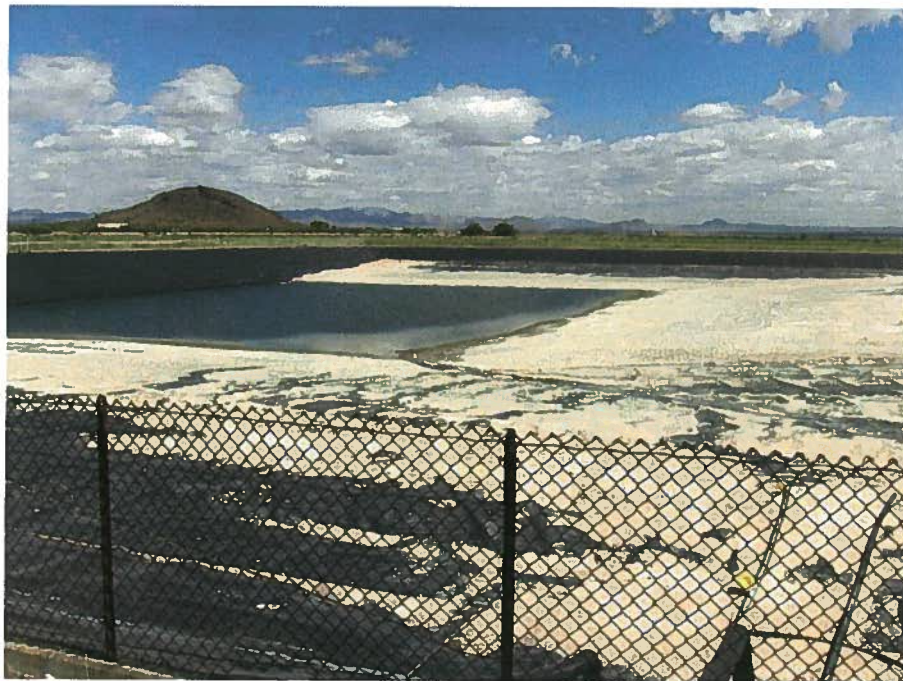
Photograph 16  
View looking east across the evaporation pond.

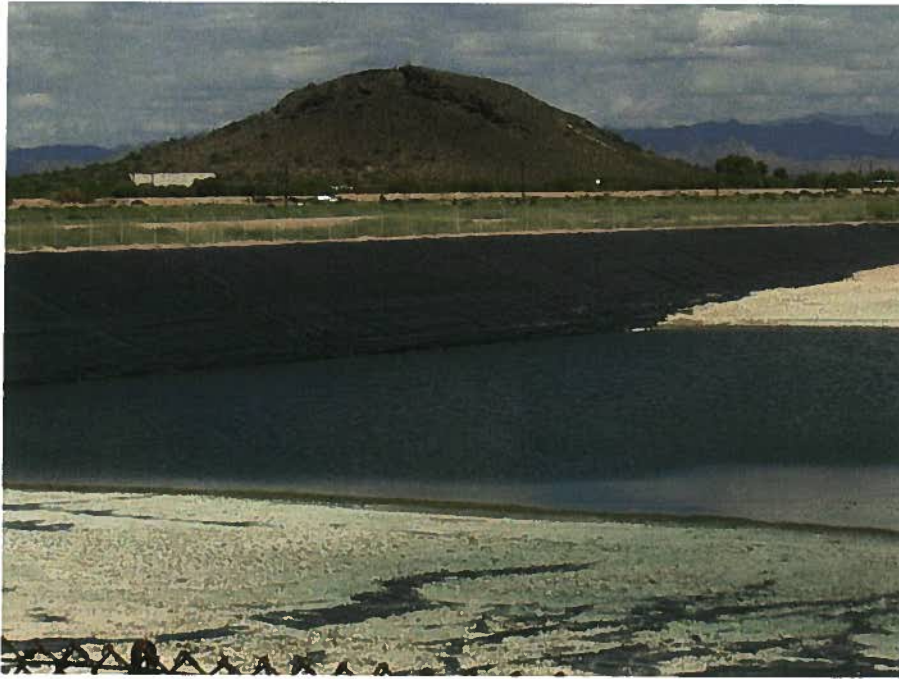
Photograph 17  
Closer view of the evaporation pond; storm water accumulation within the pond.

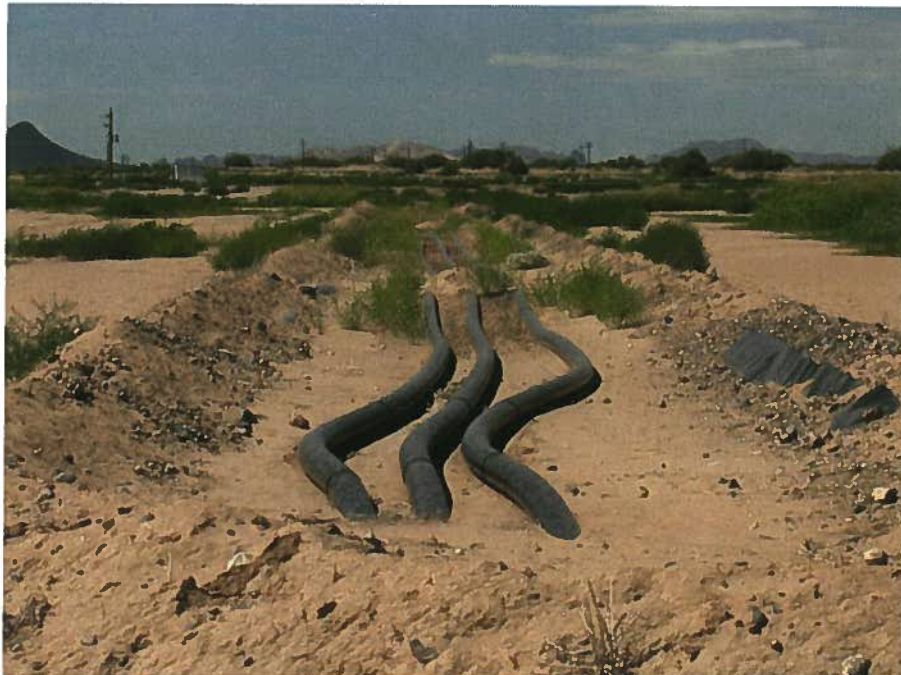
Photograph 18  
Photograph of the pipelines leading from the tank farm toward the well field.

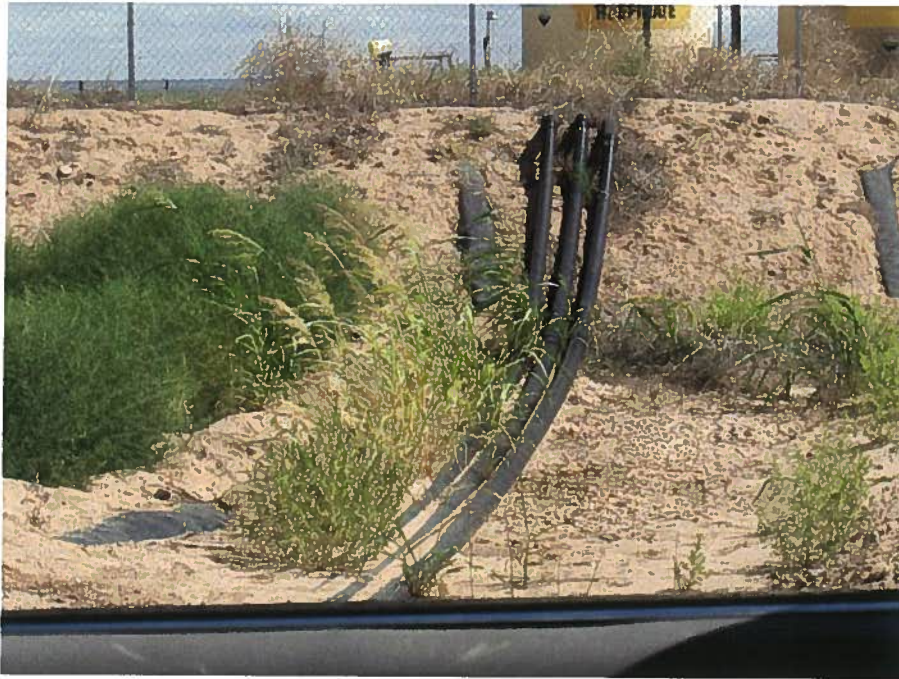
Photograph 19  
View showing the origination point of the pipeline going to the well field.
